Experiences of landslide prevention works in Vietnam

*Introduction of Landslide Disaster in Vietnam
and Application of the Japanese Technology of Landslide countermeasures*

Kawasaki Geological Engineering Co., Ltd

Takami KANNO Ph.D./PE.Jp

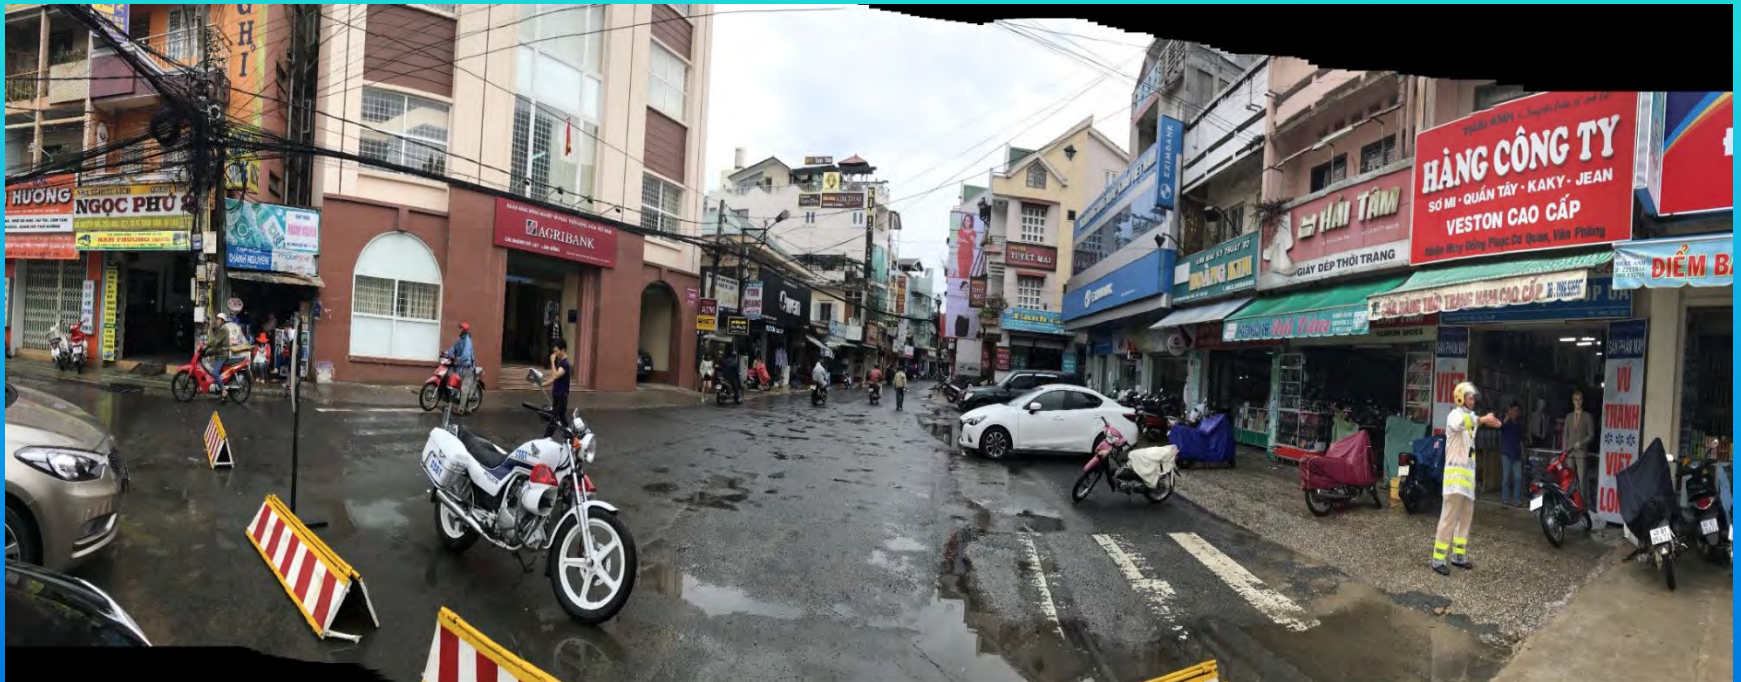
Situation near the top of the landslide immediately after the landslide in April 2017

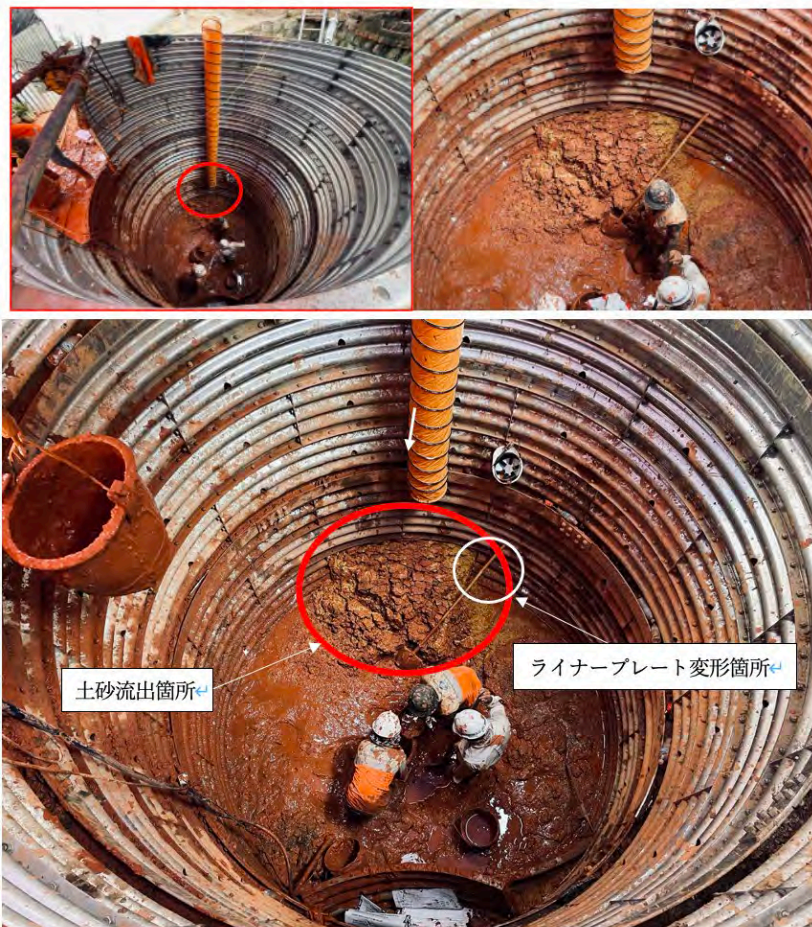
14 April 2021 Sediment runoff behind the sidewall of the drainage well by heavy rain (beginning of heaving)

As a countermeasure against heaving, grouting was carried out around the hollowed out Drainage Well.

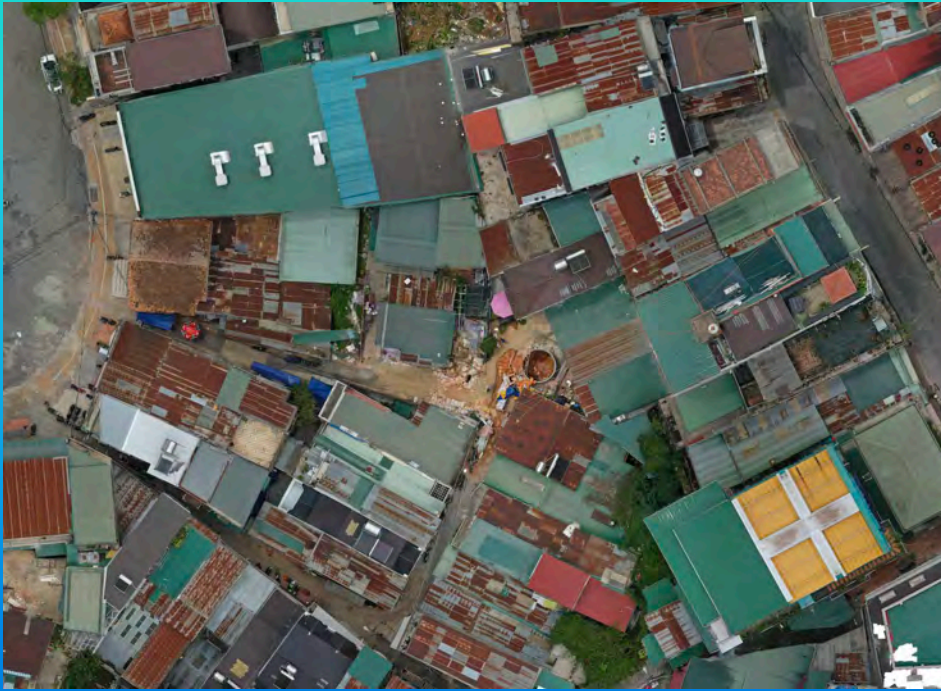
Identification of the heaving area using orthoimages and topographical contour maps created by aerial drone photography

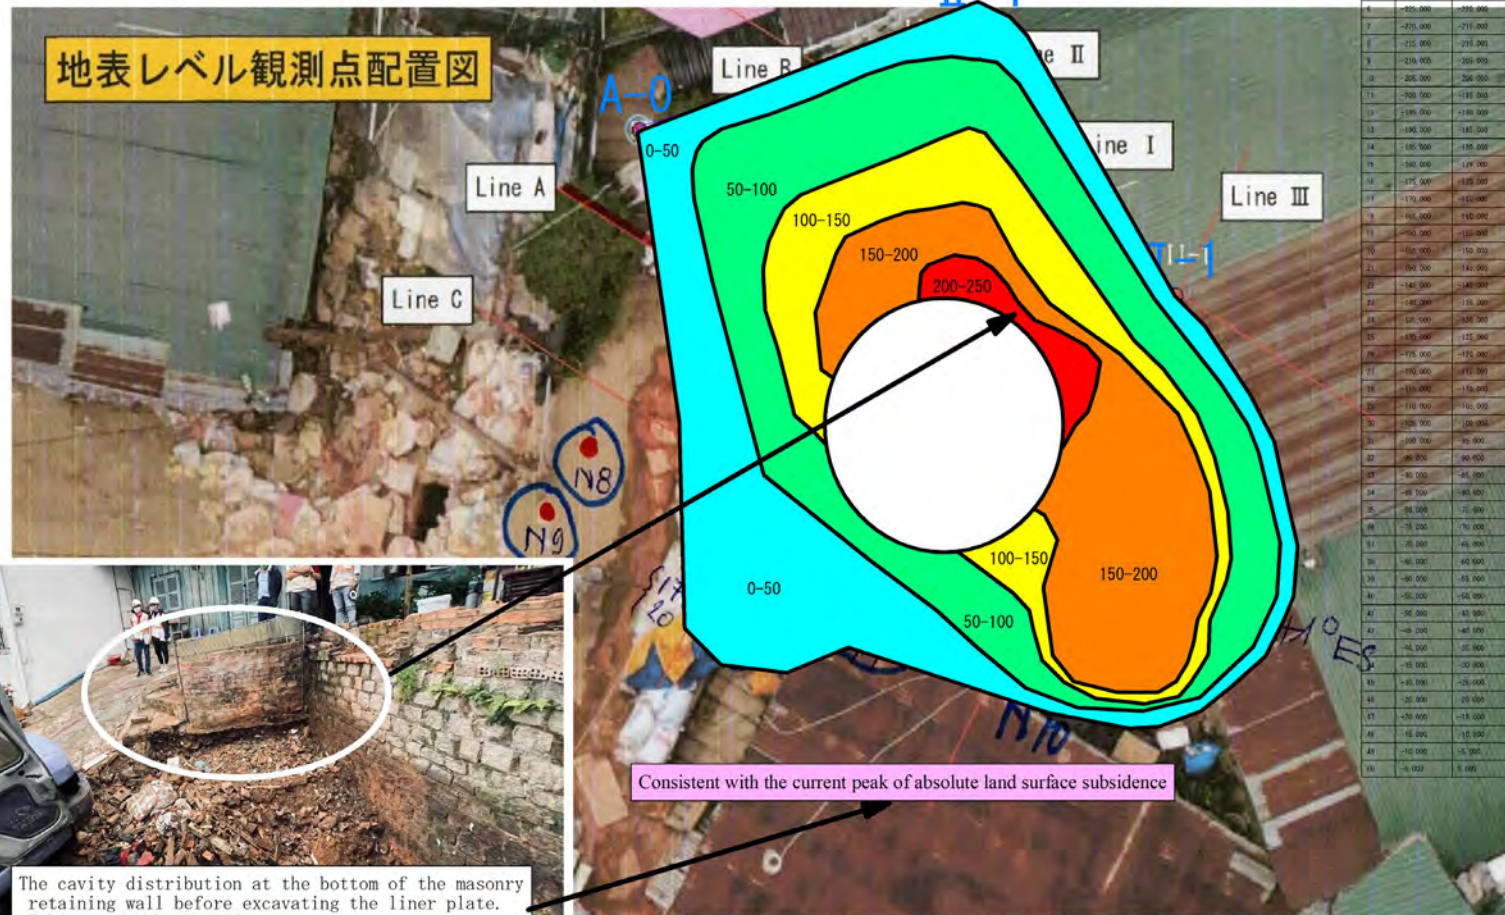
The cavity distribution at the bottom of the masonry retaining wall before excavating the liner plate.
Taken on March 19, 2021

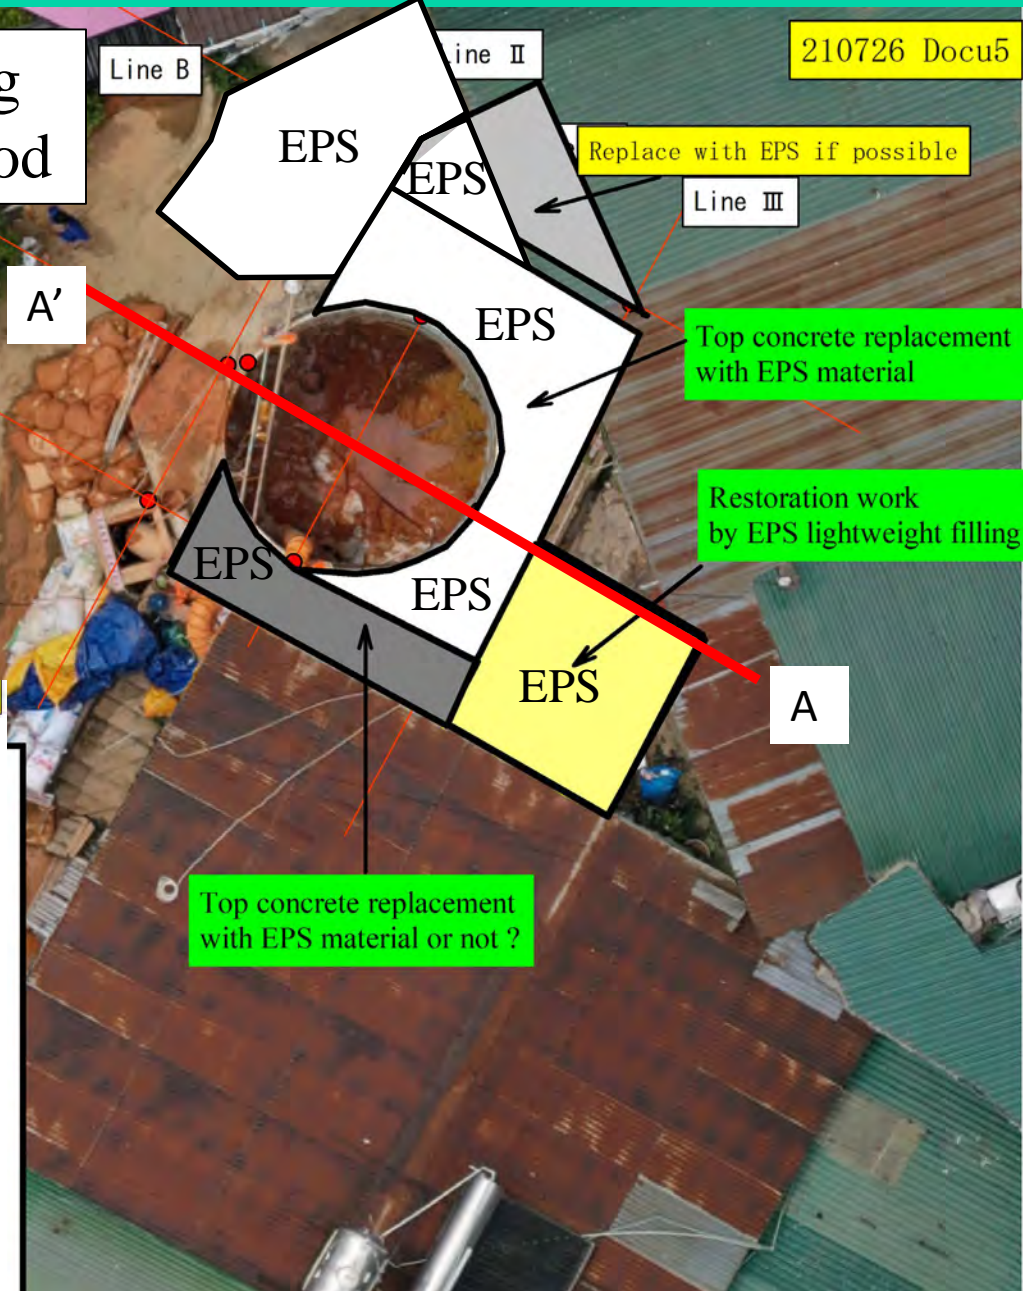
Countermeasure against heaving

Load reduction by the EPS method

A Restoration method for soil removal area by EPS (Styrolfoam)

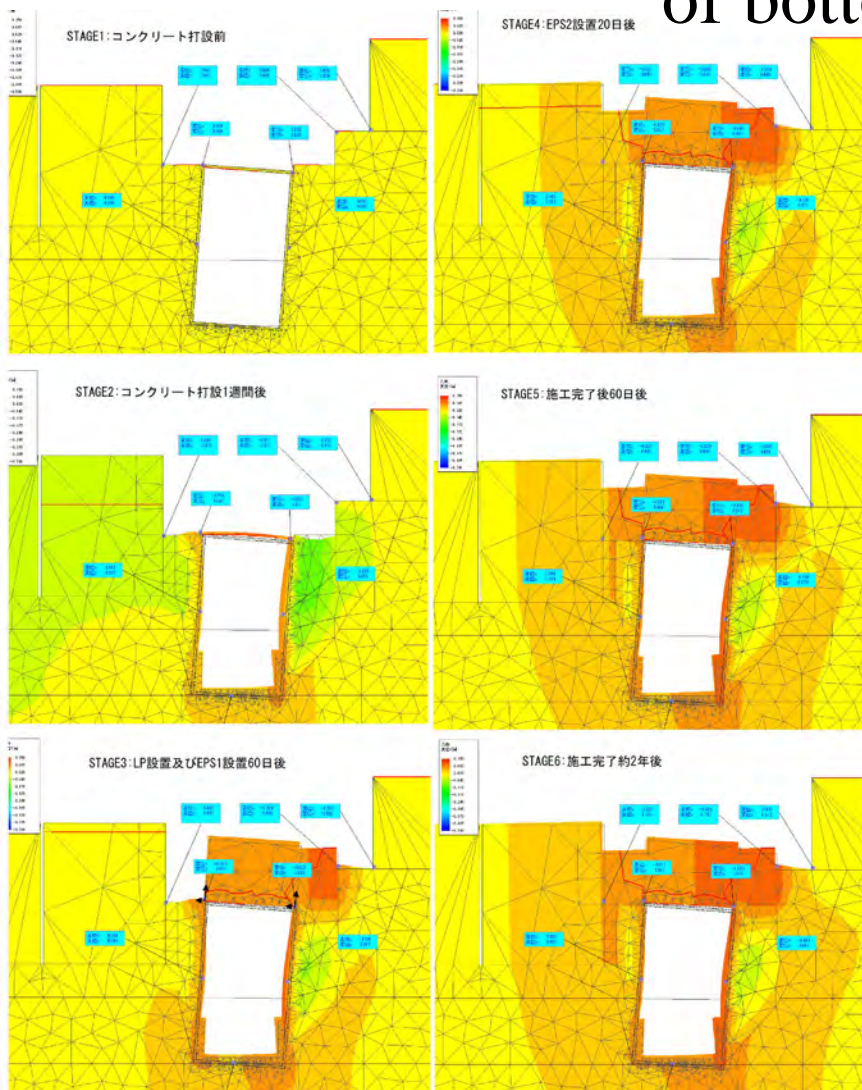
Displacement prediction of drainage well after installation of bottom concrete

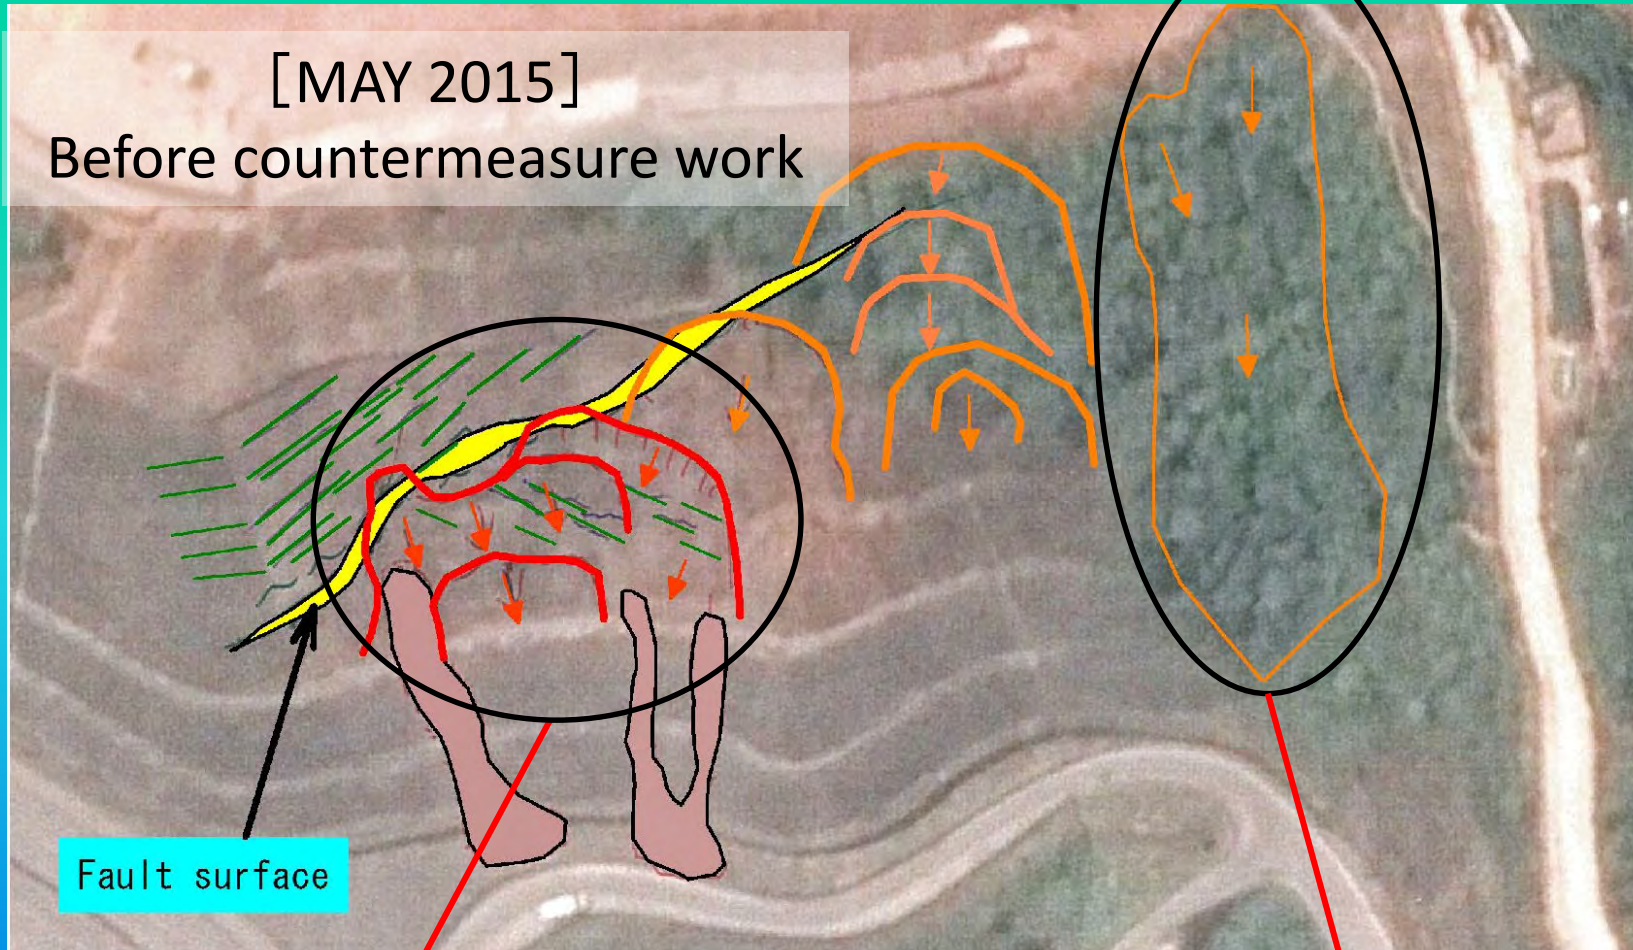
[MAY 2015]

Before countermeasure work

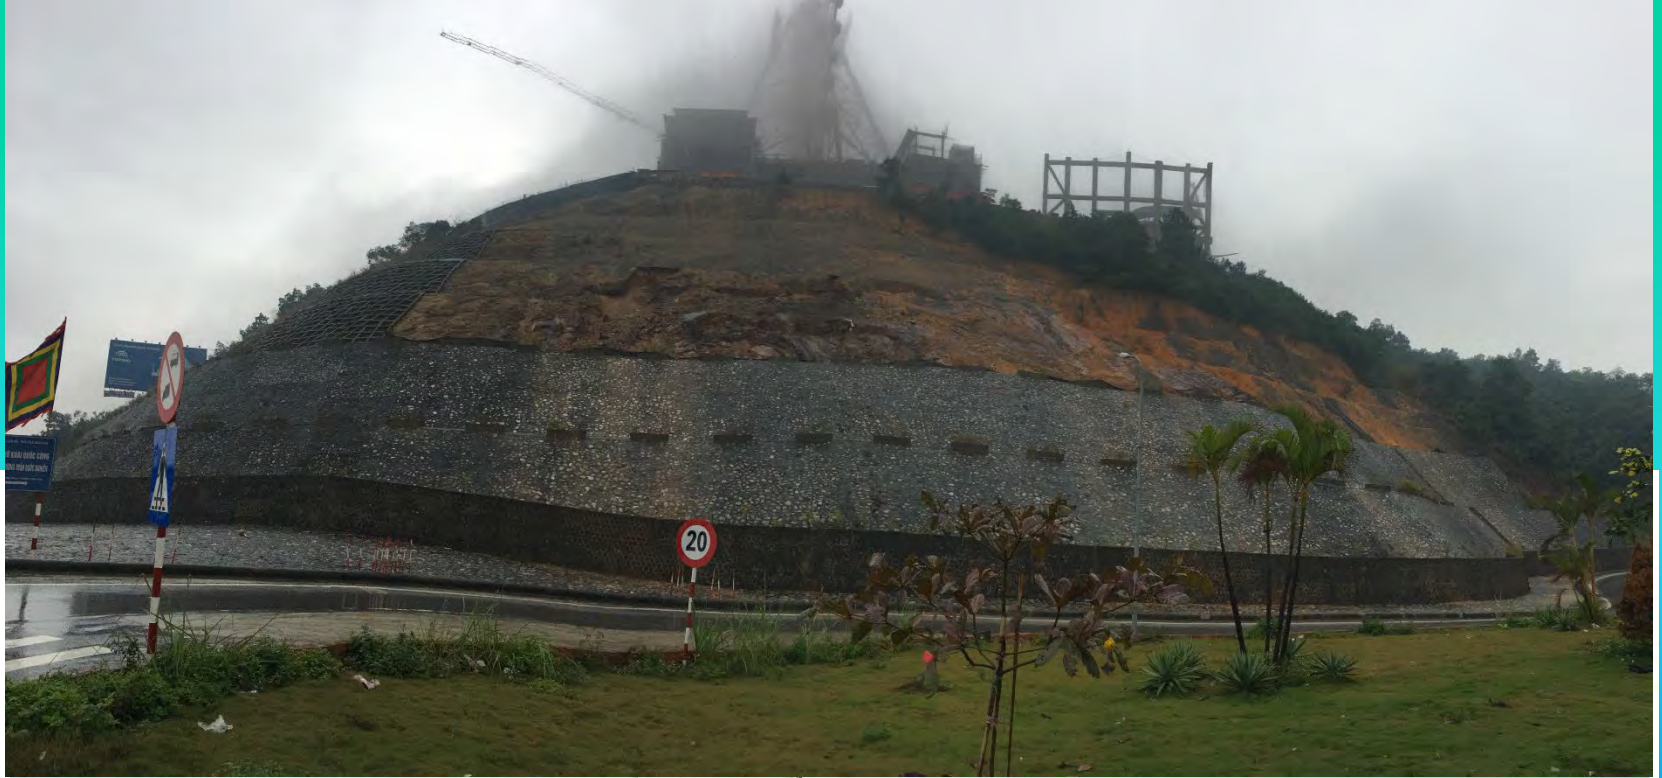
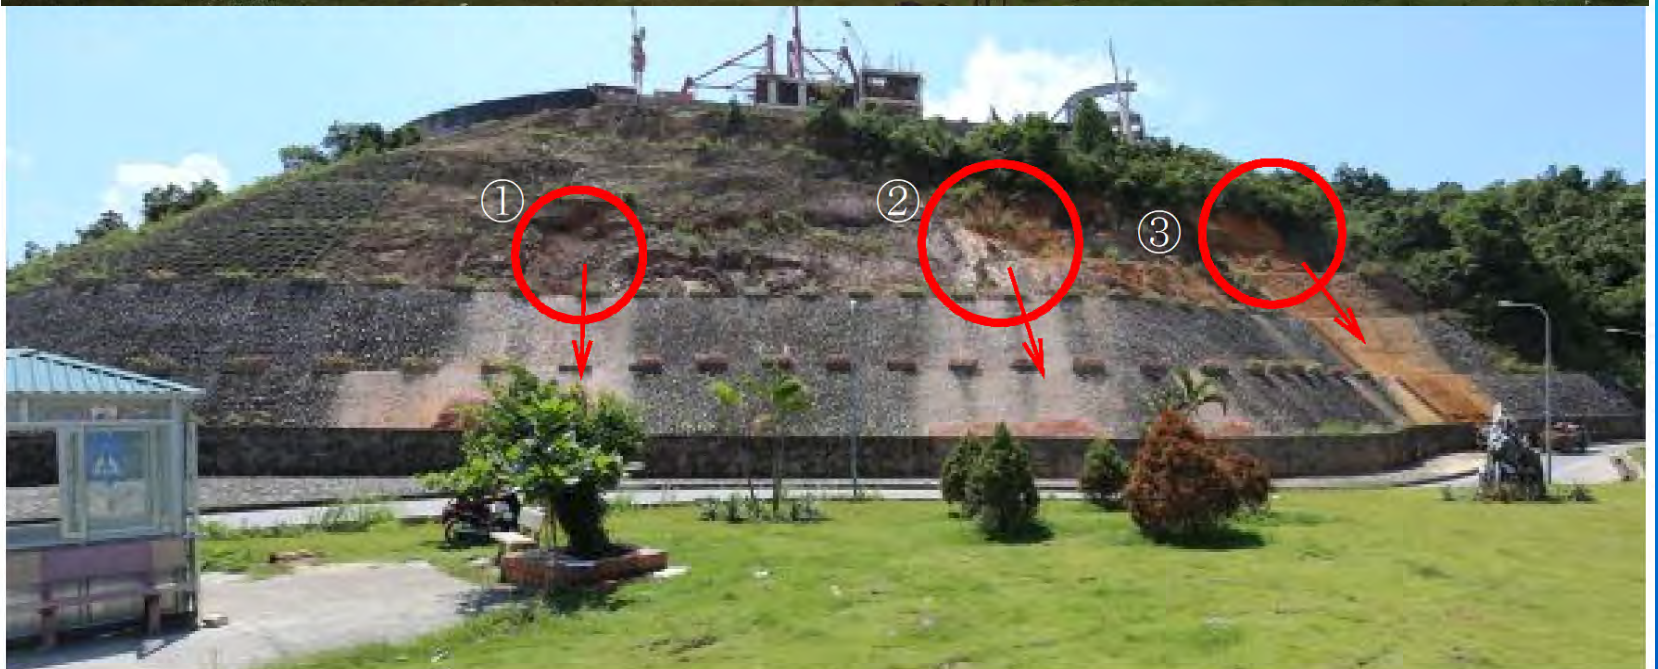
[AUG 2019]

After countermeasure work

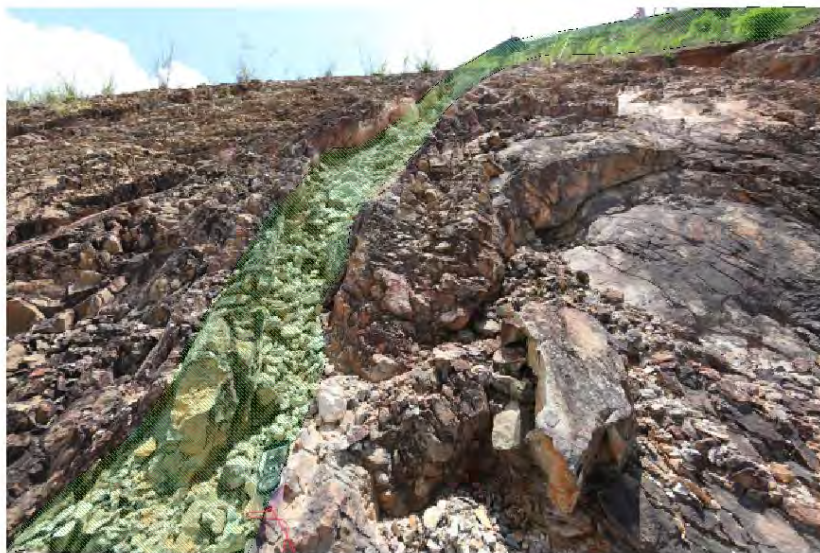
写真 9.断層ガウジを伴う破砕帯

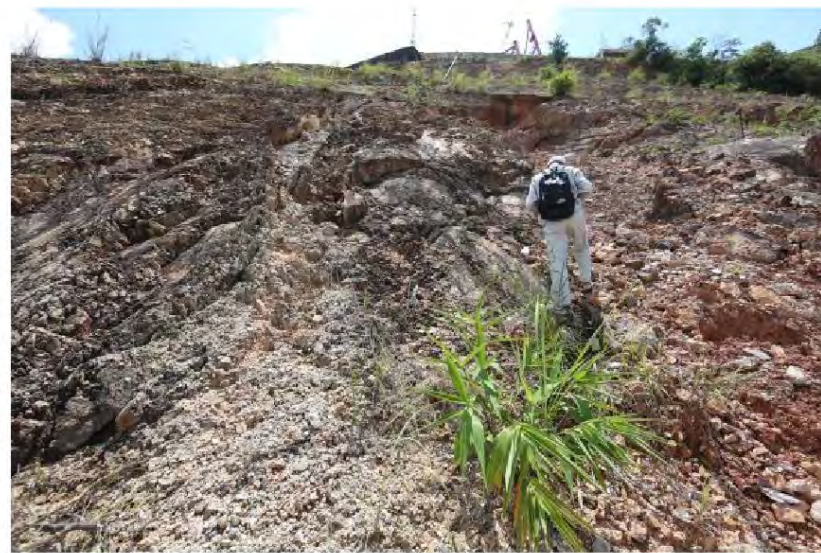
写真 10.断層下に面的に分布する破砕帯
