Experiences of landslide prevention works in Vietnam

*Introduction of Landslide Disaster in Vietnam
and Application of the Japanese Technology of Landslide countermeasures*

Kawasaki Geological Engineering Co., Ltd

Takami KANNO Ph.D./PE.Jp

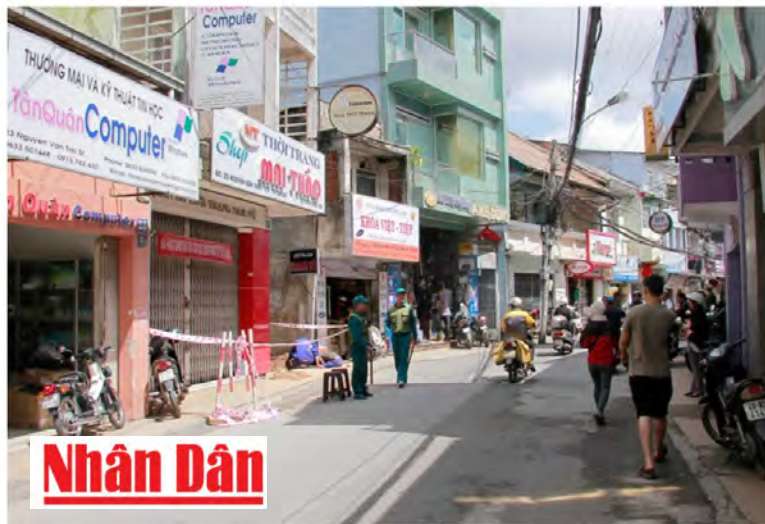
Khu vực xảy ra tình trạng nứt đất trên đường Nguyễn Văn Trỗi.

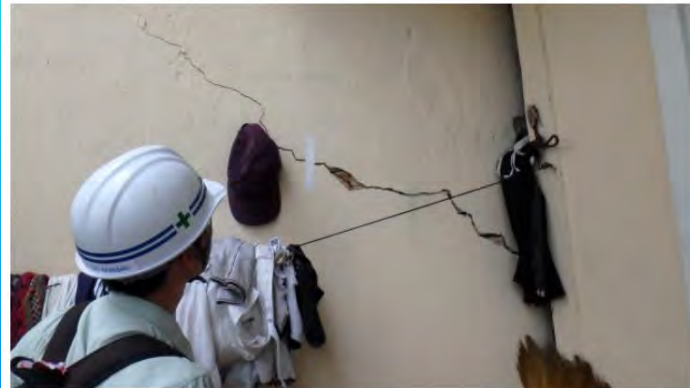
Vết nứt ngang tường tại một căn nhà trên đường Nguyễn Văn Trỗi - Ảnh: M.Vinh

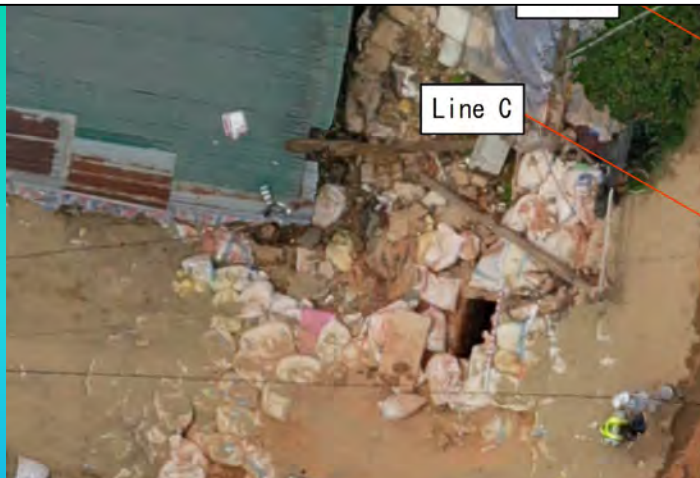
Countermeasure against heaving

Load reduction by the EPS method

A Restoration method for soil removal area by EPS (Styrolfoam)

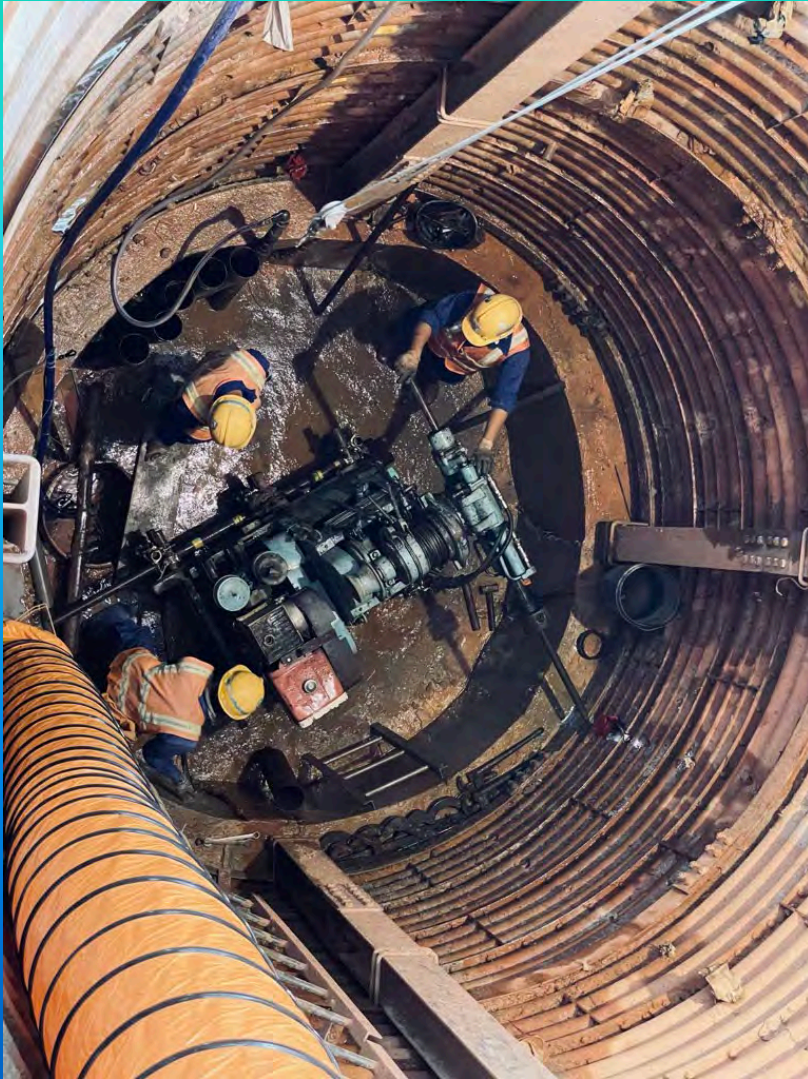
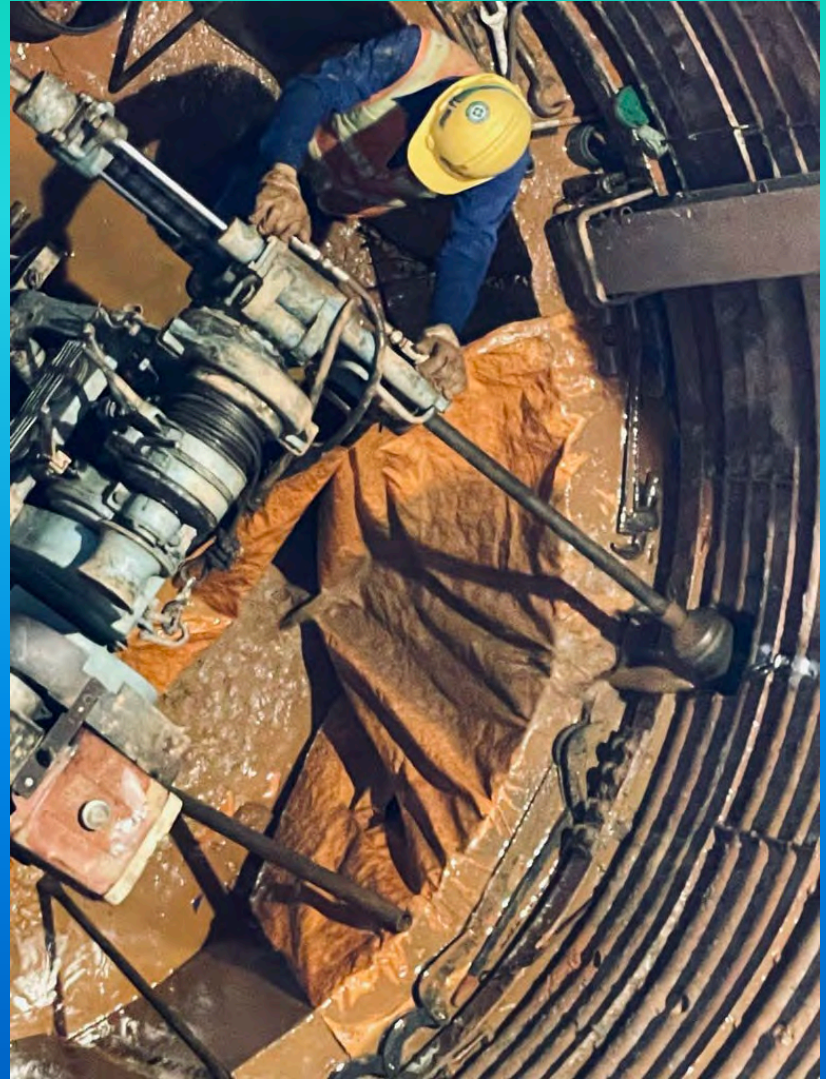
SECTION A-A

① Involving artificial ground such as embankment and garbage, weak and soft soil clay layer

② Heaving zone

2021.9.27 Drainage Drilling

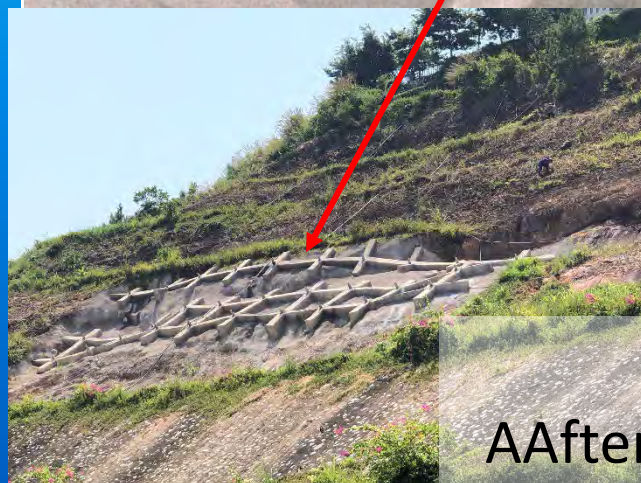
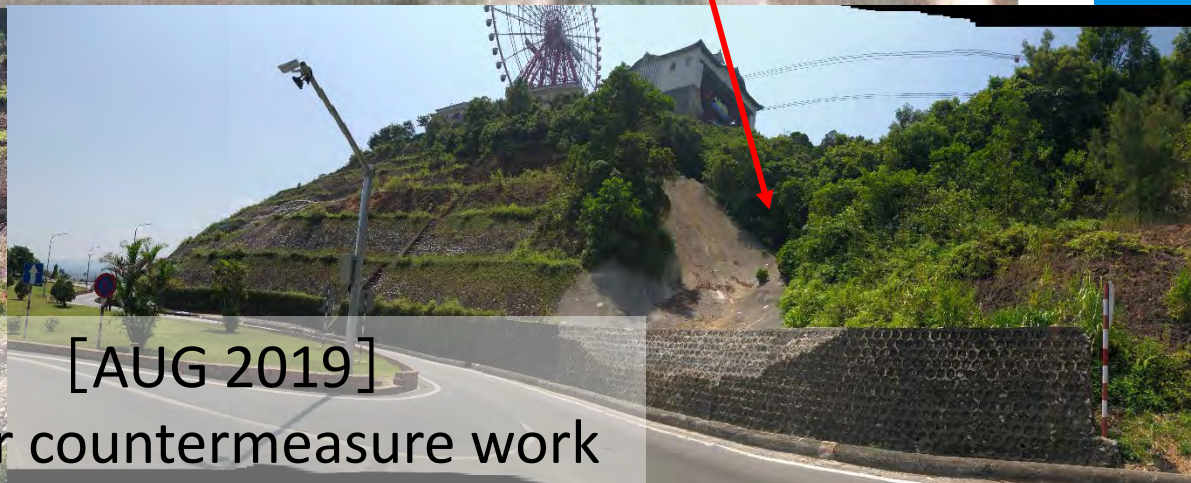
[MAY 2015]

Before countermeasure work

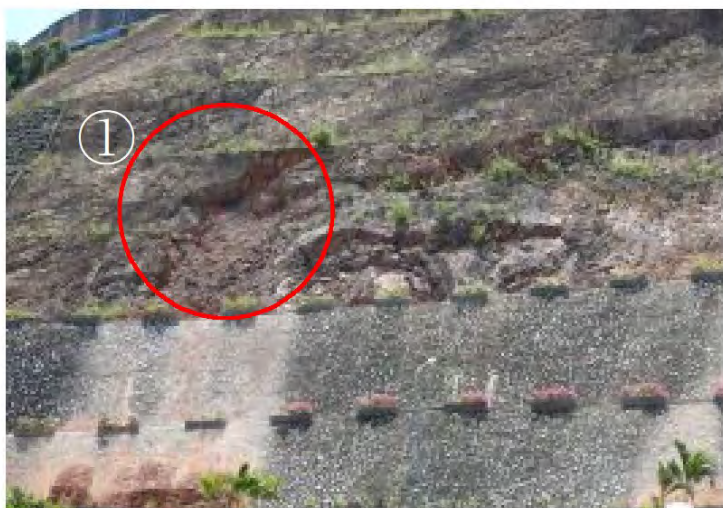
写真3.写真1の①の拡大

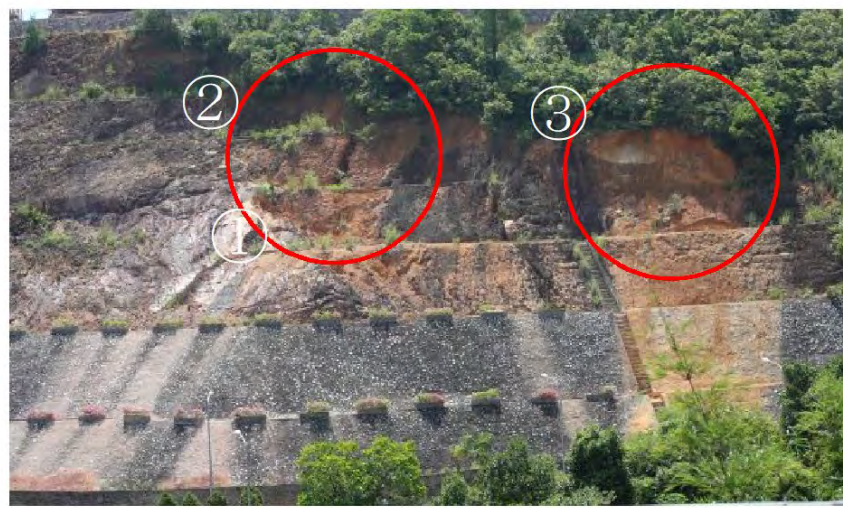
写真4.写真1の②、③の拡大

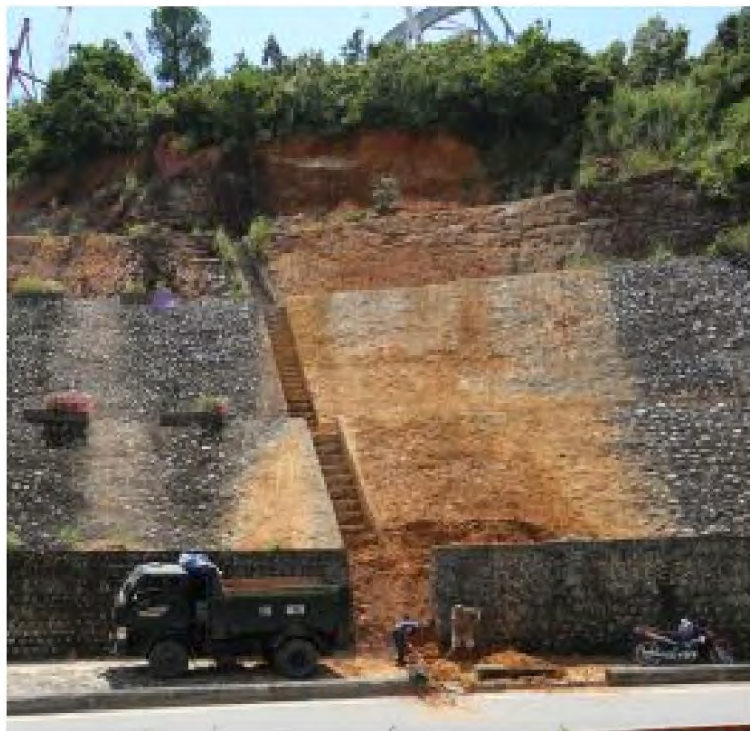
写真5.写真4の③近接写真

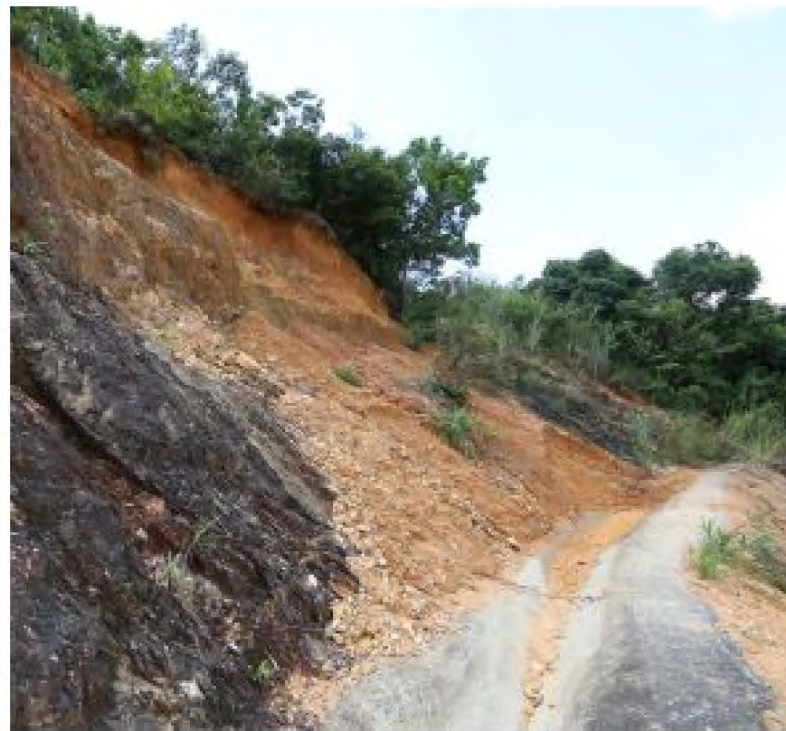
写真6.写真4の③地すべり性崩壊頂部

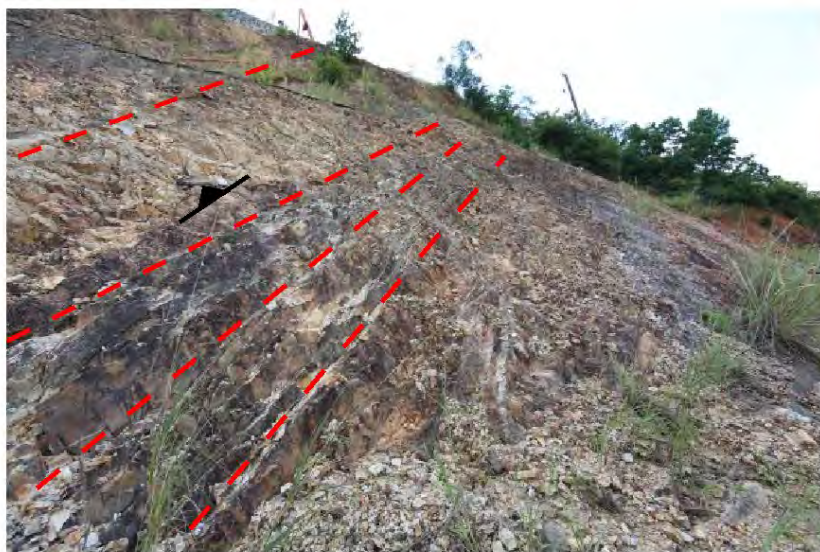
写真 7.断層上の受け盤構造の地層

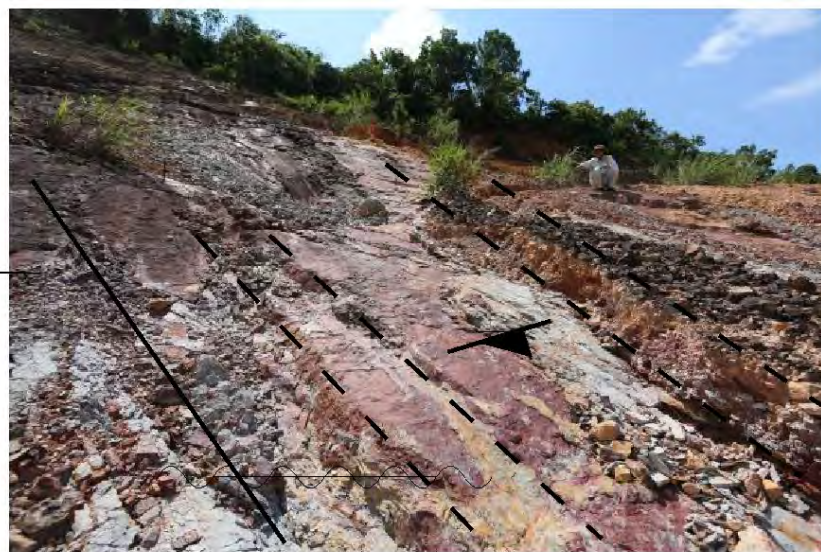
写真 8.断層下の流れ盤構造の地層

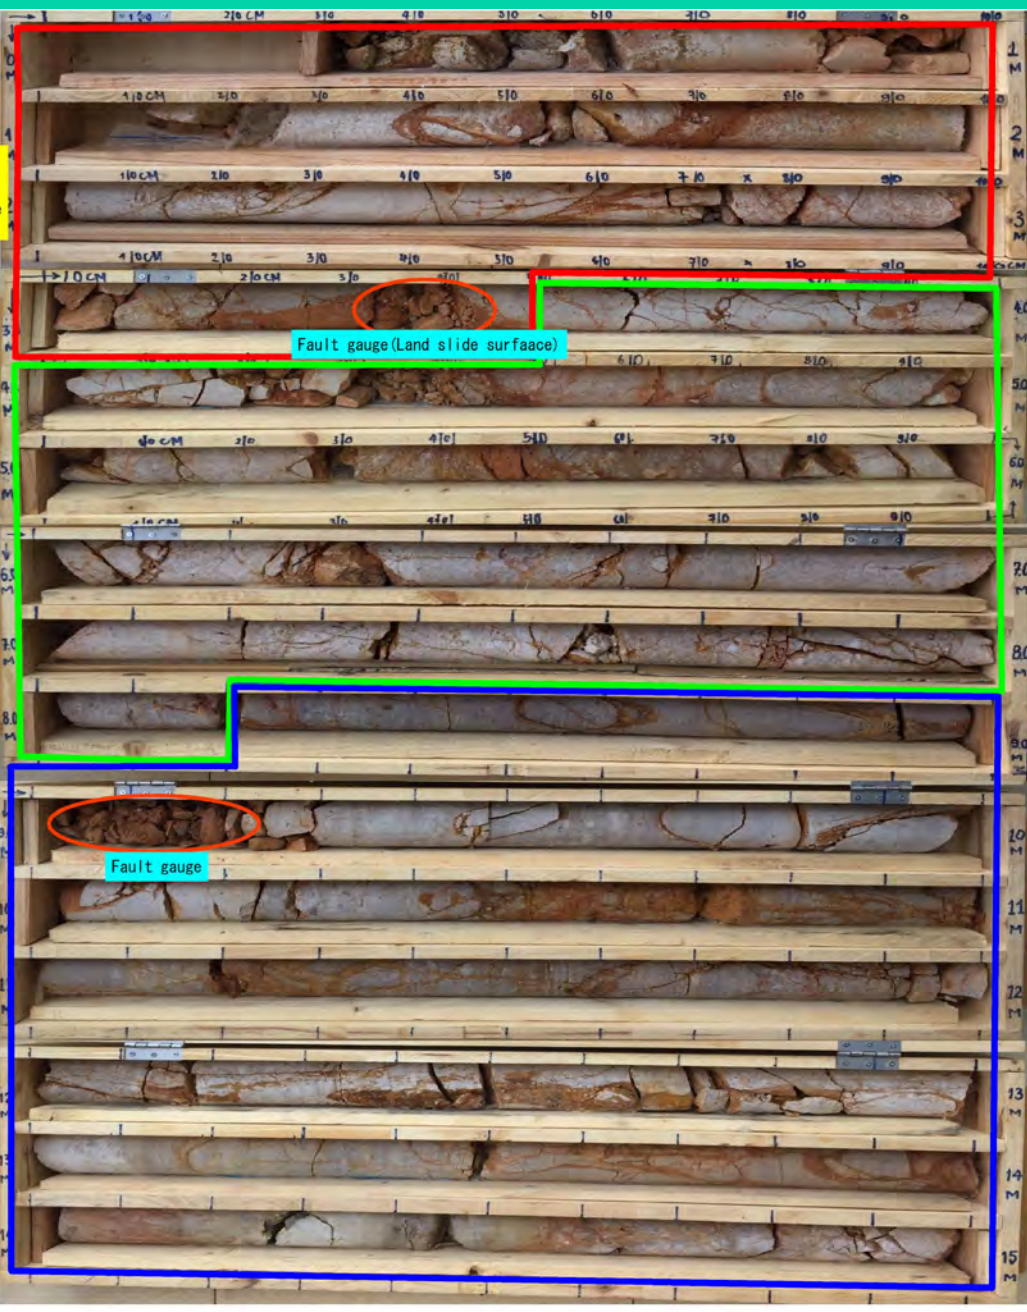
Weathered
CL-D rock

Weathered
CL rock

Concrete	Concrete
1	Strong weathered Breccia	強い風化レキ岩	Strong weathered Breccia
			From 0.1 to 0.3 m: Strongly weathering sandstone From 0.3 to 1.0 m: weathering sandstone, white gray color; The cracks filled with reddish brown clay. From 0.95 m to 1.00 m section with large cracks filled with reddish clay material. From 1.00 to 1.7m: weathering and cracking sandstone. From 1.40 to 1.70m section: Large cracks filled with reddish clay material
2		破碎質粘土	Shear clay
			Shear clay (clay with gravel and sand)
3		風化レキ岩	Weathered Breccia
			From 1.8 to 2.0m: weathering and cracking sandstone. From 2.0 to 2.75m: weathering sandstone and pudding-stone. From 2.75 to 3.35m: weathering sandstone and pudding-stone; white gray color
4		破碎質粘土	Shear clay
			Shear clay (clay with gravel and sand)
		風化レキ岩	Weathered Breccia
			From 3.45 to 4.25m section: strongly weathering sandstone and pudding-stone.
		故障箇所 風化レキ岩	Fault gauge

Fault gauge
5		風化レキ岩	Weathered Breccia
			From 4.50 to 5.5 m section: weathering sandstone and pudding-stone
6		破碎質粘土	Shear clay
			Shear clay (clay with gravel and sand)
7		風化レキ岩	Weathered Breccia
			From 5.6 to 6.35 m: weathering sandstone and pudding-stone. From 6.35 to 7.20 m: weathering sandstone and pudding-stone; hardly stone. (the crack filled with reddish clay material) From 7.20 to 8.20 m: weathering sandstone and pudding-stone; hardly stone (the crack filled with reddish clay, sand and quartz material) From 8.20 to 9.0 m: weathering sandstone and pudding-stone; hardly stone (the crack filled with reddish clay, sand and quartz material)
9		故障箇所 風化レキ岩	Fault gauge
			Fault gauge
10		風化レキ岩	Weathered Breccia
			From 9.2 to 10.45m: weathering sandstone and pudding-stone; hardly stone (the crack filled with reddish clay material) From 10.45 to 10.70m section: The crack filled with reddish clay, sand and quartz material.
